## Exterior wall details

Project W

## Interior wall details

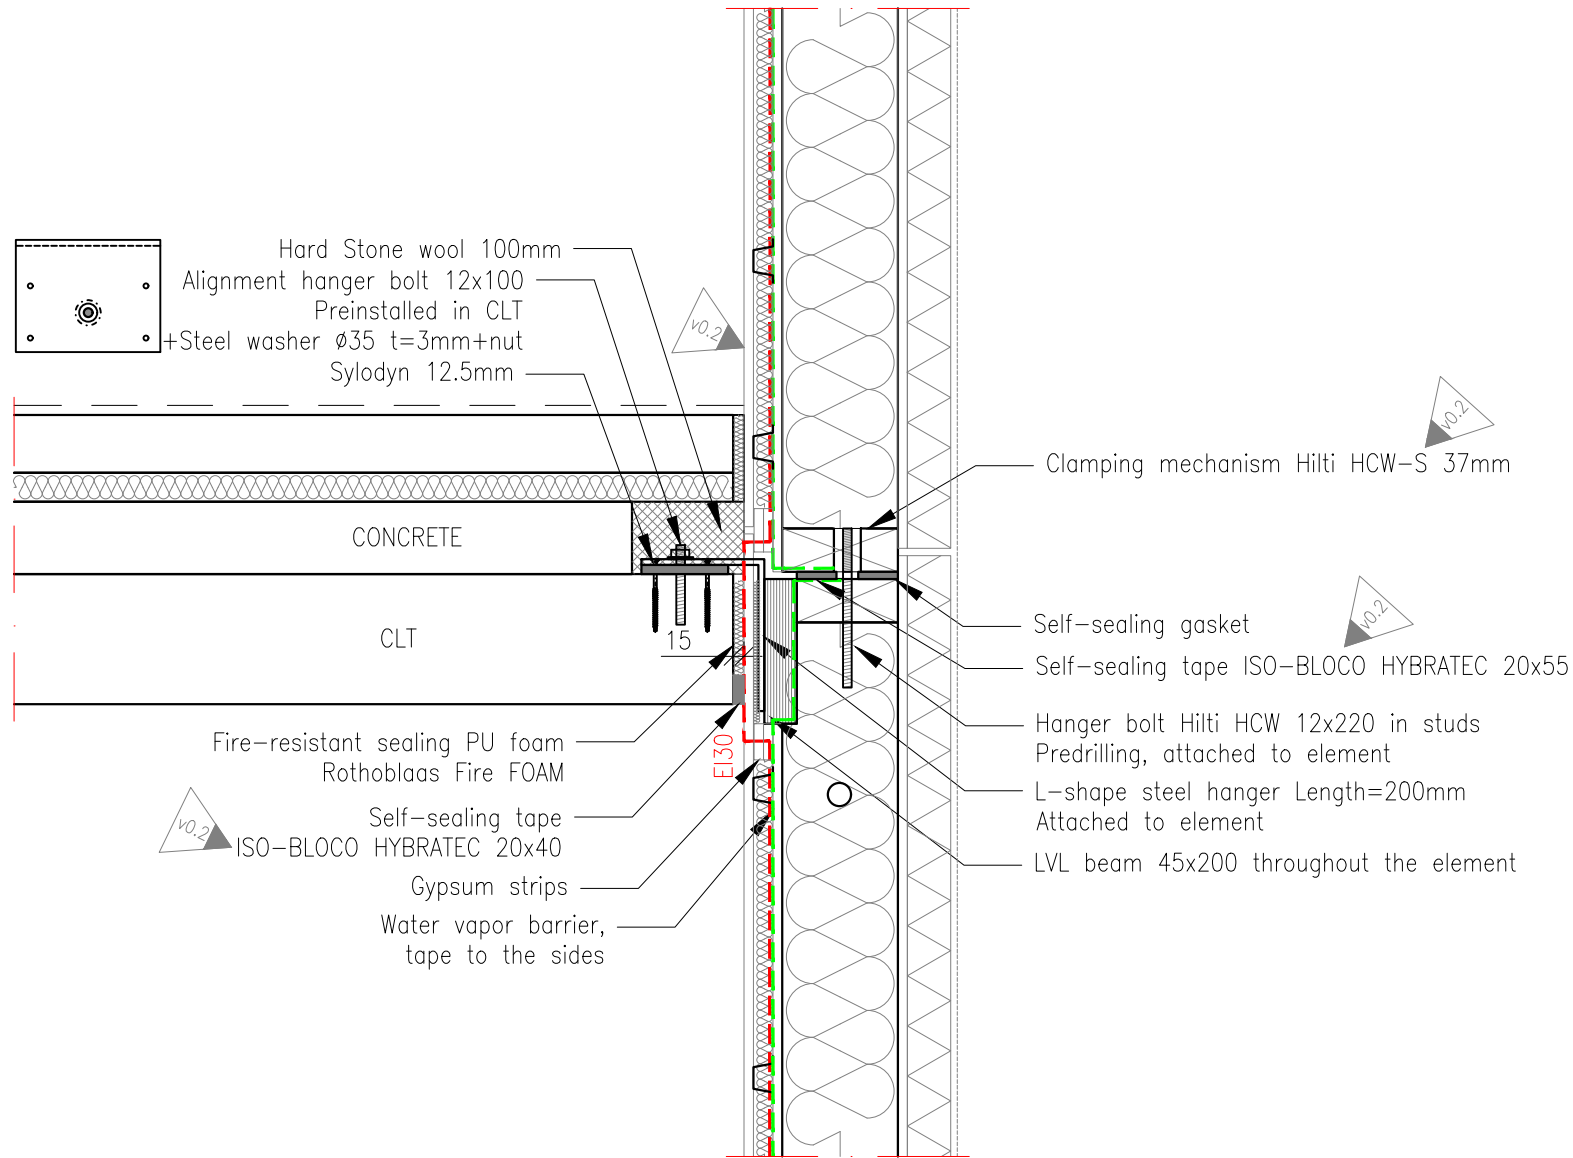
## DET. EXT.W-1

Horizontal connection  
of exterior wall elements

v0.2 4.6.25 S.B.  
DET. EXT.W-1  
- Interior gypsum is continuous  
- HCW connector is specified  
- Neoprene is replaced by self-sealing tape  
DET. EXT.W-2  
- Neoprene is replaced by self-sealing tape

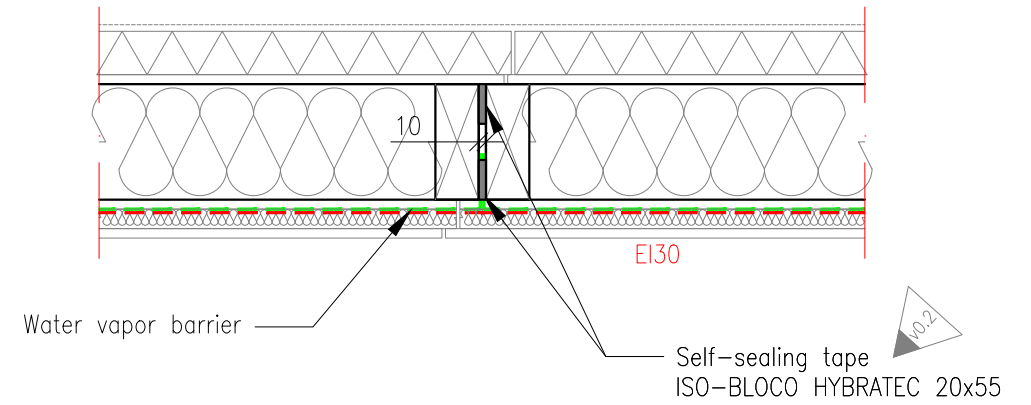
## DET. EXT.W-2

Vertical connection  
of exterior wall elements

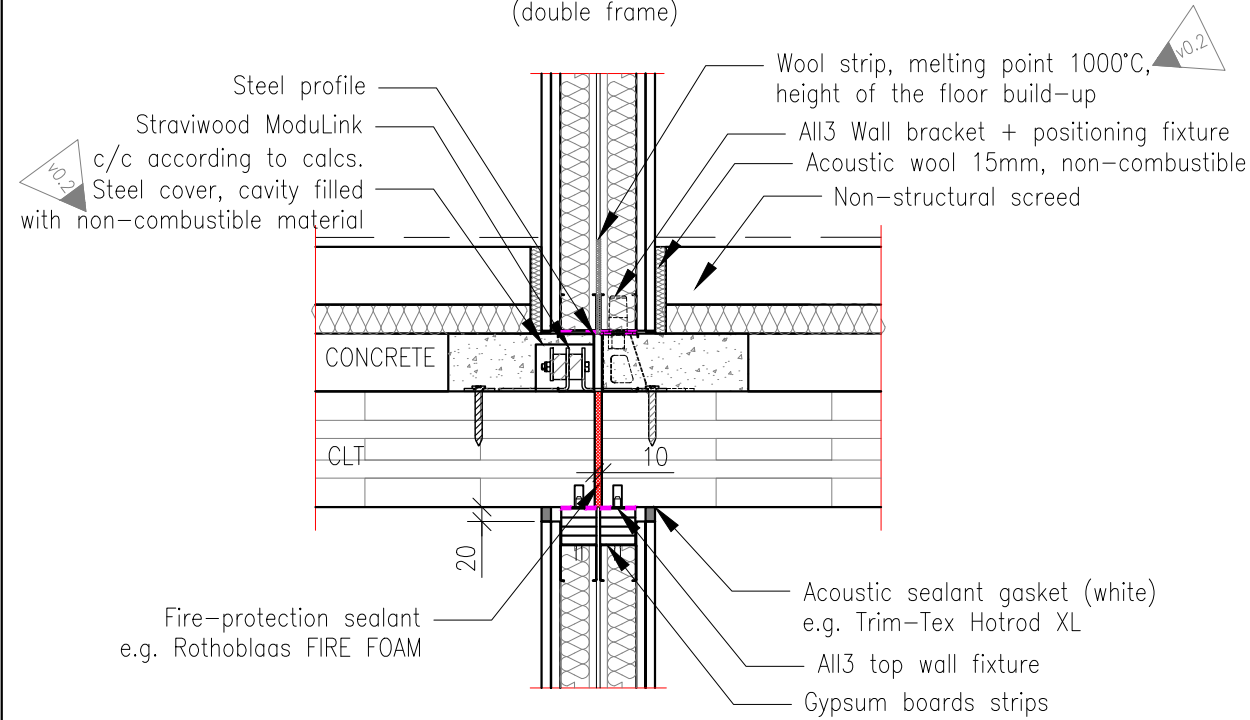
## DET. INT.F-1

Slabs connection  
above non-load bearing wall  
(double frame)

v0.2 4.6.25 S.B.  
DET. INT.F1

- Wool strip between the walls
- Cavity around Modulelink is filled with non-combustible material

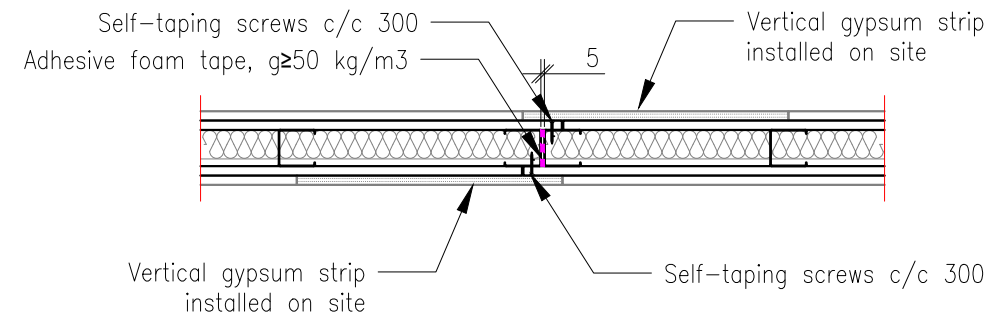
## DET. INT.W-1

Interior walls butt connection

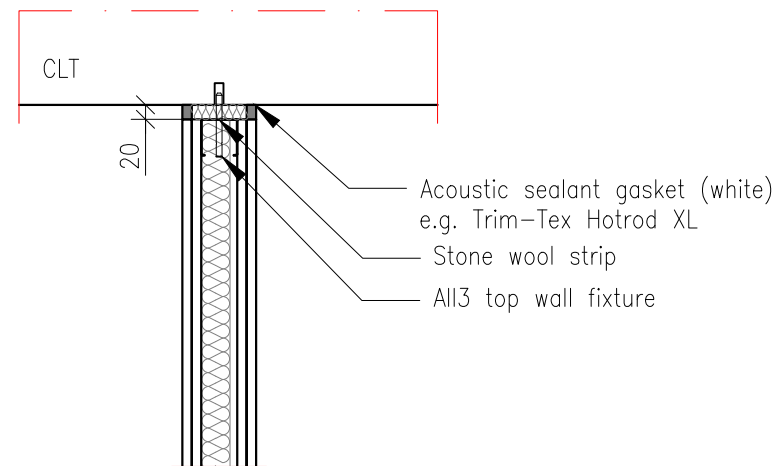
## DET. INT.W-2

Interior wall and ceiling connection

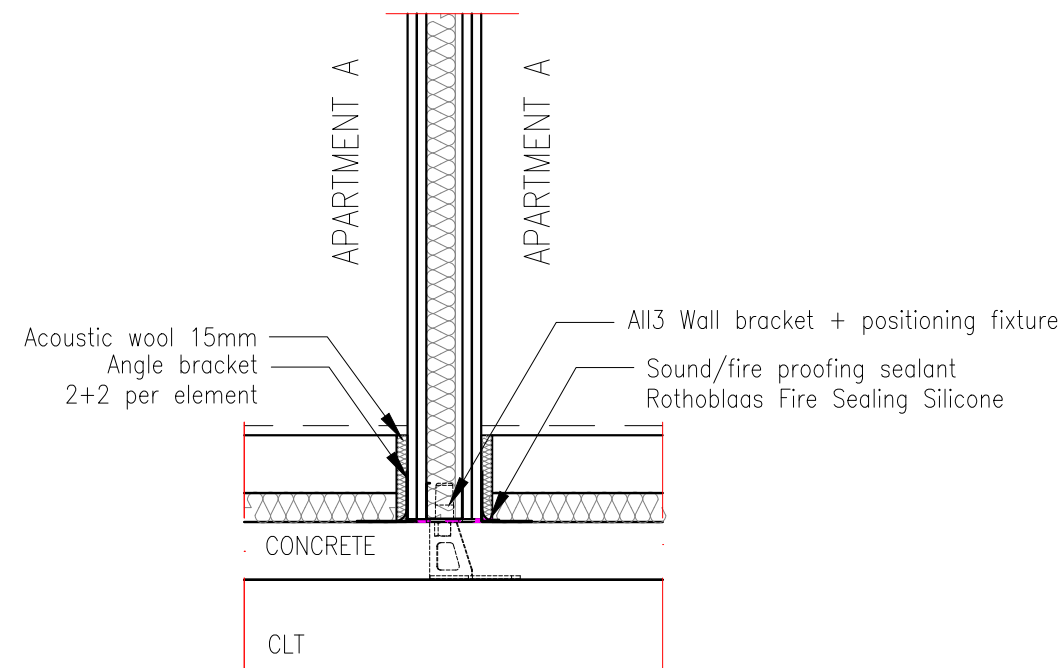
## DET. INT.W-3

Interior wall and floor connection  
using All3 alignment fixtures
